Build 5/New VCP Status Update

NEXRAD TAC - Information Brief

March 2004

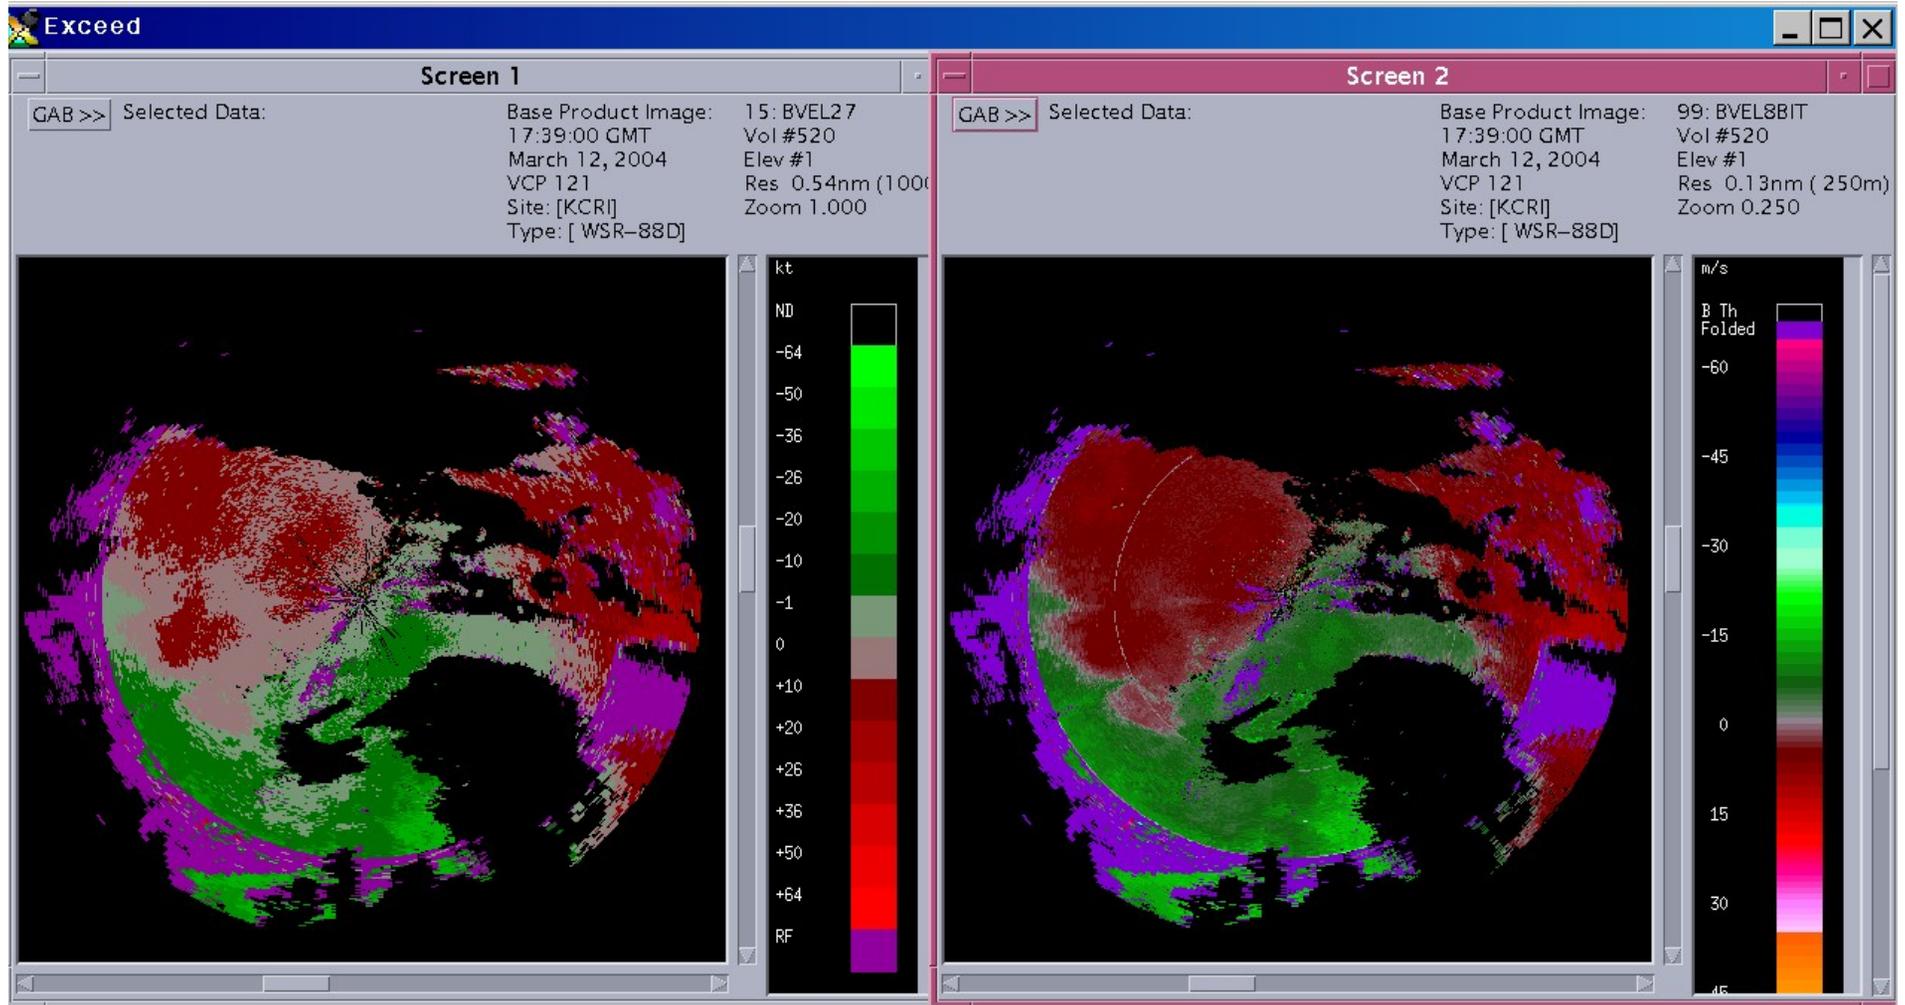
- Issue: Rings in the Velocity and Spectrum Width Products
- Frequency of occurrence: At lower elevations scans (0.5 - ~2.4 degree), when weather is present, at approximately 60-80 nm
 - Adjusting adaptable parameters helps, but ranges allowed are too tight to completely remove the rings in all cases
- Solution:
 - Build 5.0: Make adjustments in MPDA adaptable parameters within ranges provided
 - Build 6.0: Ranges in the MPDA algorithm are expanded to completely remove the rings
