# A Guide to WSR-88D Data Quality Phenomena and Anomalies

Radar Support Team  
Operations Branch  
Radar Operations Center  
Norman, OK 73069  
August 2024

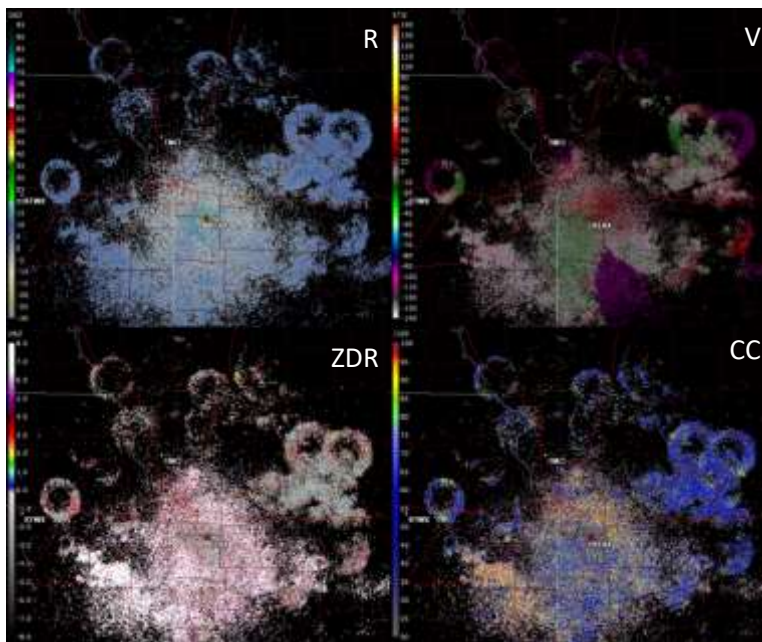
Bird signatures over northern and central Missouri and eastern Kansas during clear air.

Other examples of WSR-88Ds detecting biological targets include birds and bats departing roosts and caves. Birds are often seen flying away from their nesting grounds near sunrise while bats are seen flying away from their caves near sunset. The radar returns often start out in a circular appearance, then gradually disperse as the animals change their course. They often show divergent velocity signatures, and Dual-Pol variables add to the confirmation that these returns are biological. CC and ZDR estimates are influenced by the orientation of the biological targets with respect to the beam. For more discussion related to the impact of the shape of the biological targets on the scattering of the beam as well as interpretation of WSR-88D products refer to <https://esajournals.onlinelibrary.wiley.com/doi/10.1002/ecs2.1539>.

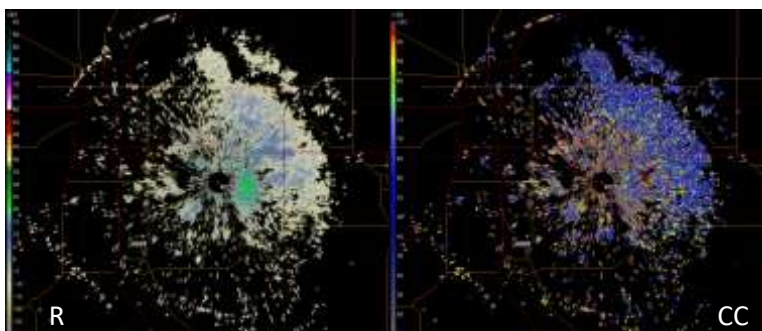
Biologicals often take flight immediately following an earthquake in their vicinity. A 4.3 earthquake occurred near Edmond, OK at 11:39 UTC on 29 December 2015 causing thousands of biologicals to take flight. The images below illustrate this phenomenon where the yellow star shows the location of the epicenter.

The images to the left are from 1.5°, two minutes after the earthquake.

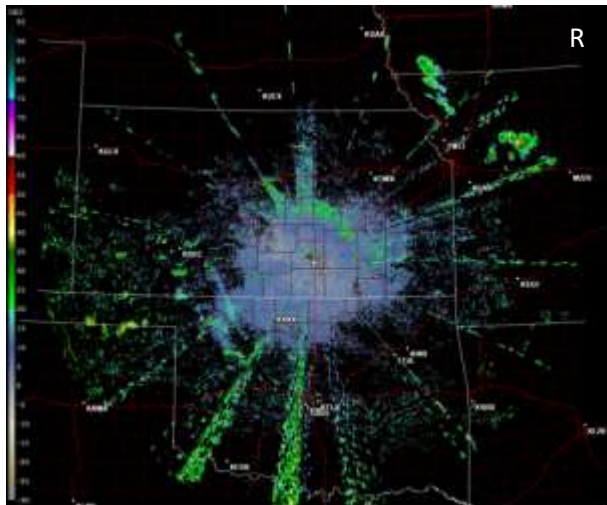
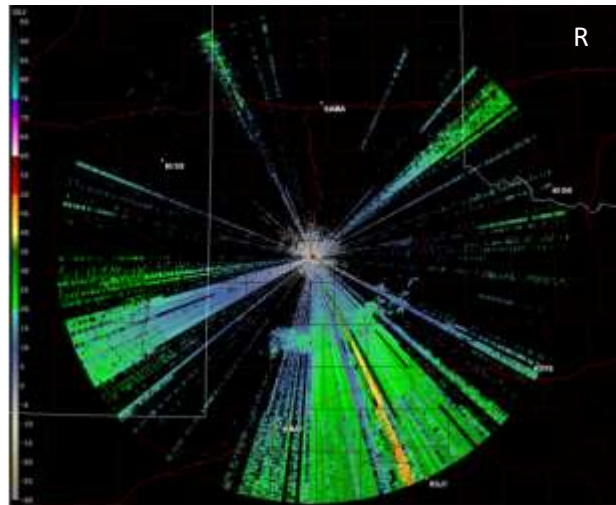
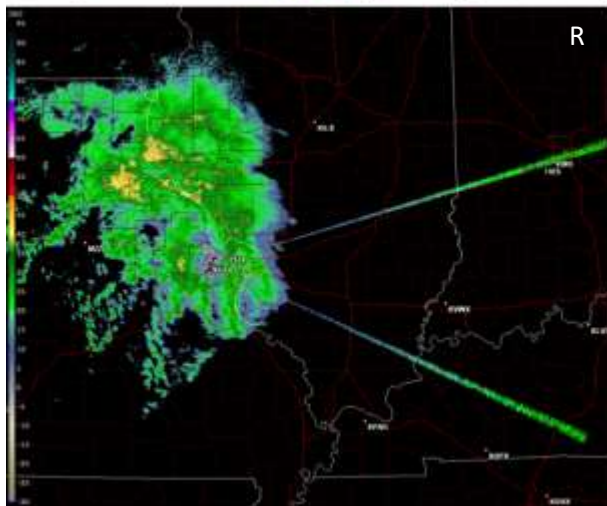
Interference is a rather common observation in WSR-88D data and has different appearances depending on the interfering source. A few examples of sources include cell phone towers, aircraft, and other radar systems. Some WSR-88Ds may only observe interference during beam ducting conditions or inversions while other WSR-88Ds may observe interference more consistently. Data images of some interference signatures follow.

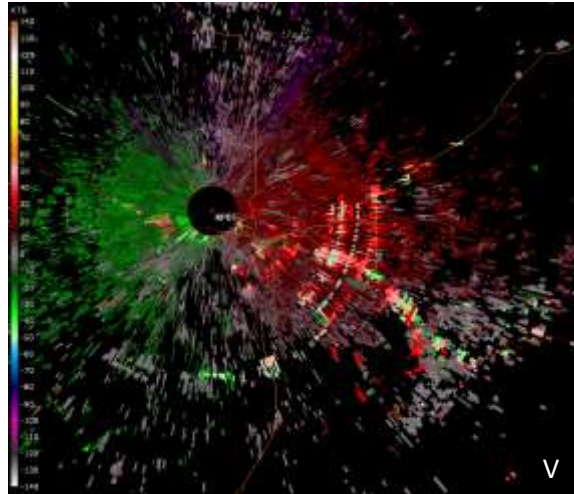
Sidelobe contamination can also manifest as small arcs as seen in the images below. Contamination from traffic along the highway can also be observed in the image.
